TEST REPORT

Full scale bushfire deck test of Trex®
Transcend™ Grooved decking boards in
accordance with AS1530.8.1-2007

2824602

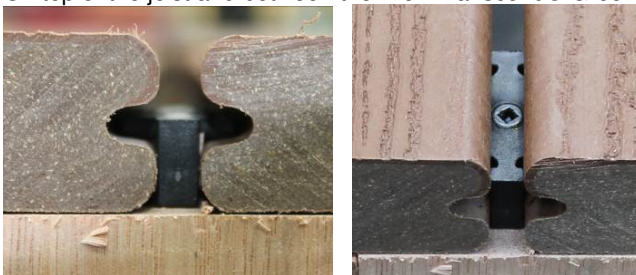
Fixing	The decking board was secured with Trex Hideaway® Universal fastener (item 2) and 10G × 65mm CAP-TOR Decking screws at the edge of the deck.
2	Name	Trex Hideaway® Universal fastener
	Material	Fastener: Glass Filled Nylon Screw: Stainless Steel
	Size	Self-gapping connector clip: 13.1mm high × 31.8mm wide × 19.0mm deep Screw: Ø4.5mm × 40mm long
	Installation	On top of the joist and between the Trex Transcend® Groove decking board (item 1)

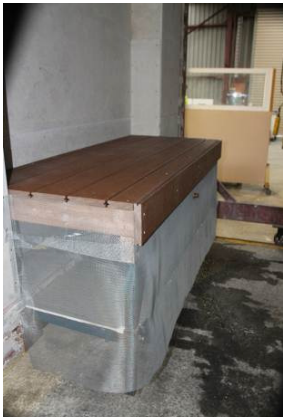
Item	Description	
		with two screws at each support location.
7	Name	Sub-floor of deck
	Material	F17 Grade Hardwood (KD. hardwood)
	Size	90mm × 45mm
	Density	660 kg/m ³
	Moisture Content	Average of 11.7% for the joists Average of 10.8% for the bearers
	Fixings	2-off 3mm diameter × 75mm nails on each joist to the bearer
	Installation	5-off 750mm long lengths to form the joists that were located perpendicular to the wall, at nominal 450mm centres. 2-off 1800mm lengths to form the bearers were located parallel to the wall; the bearers were located at the front and the back edge of the specimen.
8	Name	Wall framing
	Material	90mm × 45mm MGP10 timber
	Density	540 kg/m ³ (measured)
	Installation	Assembled using 3 inch gun nails
9	Name	Metal mesh
	Material	Stainless steel
	Size	0.4mm thick with 1.87mm square hole
	Installation	<p>The mesh was stapled to the joists and front fascia, to ensure no gaps greater than 3mm in diameter to the subfloor area. The mesh was fixed to a “floor” of 6mm thick cement sheet as shown below.</p>

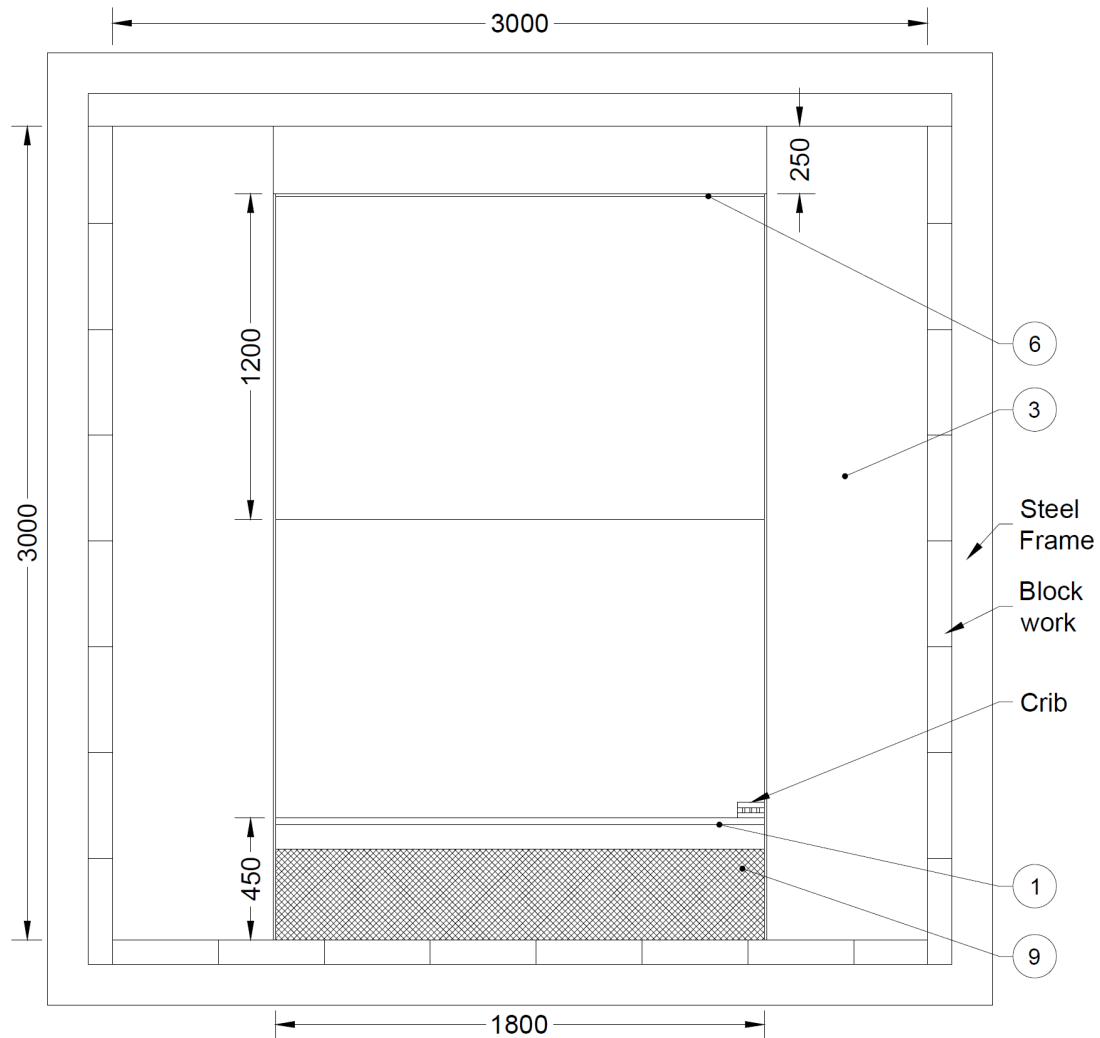
Figure A1.1: Exposed side elevation of test specimen.

Full specimen details are provided in Figures A1.1 to A1.6 and the 'Schedule of Components' in Section 2.

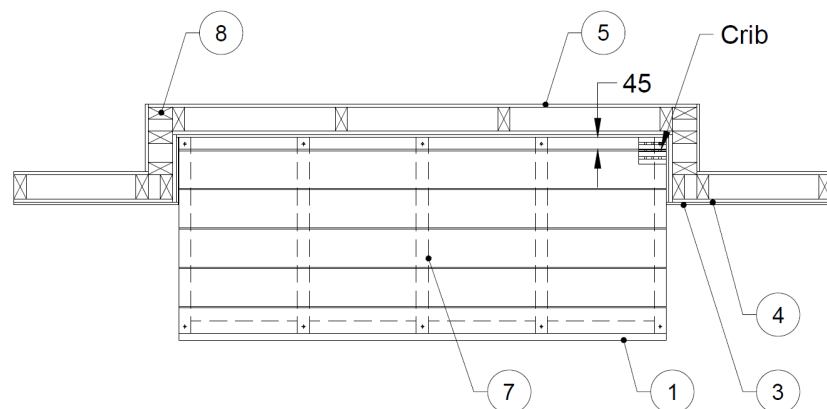
Figure A1.2: Horizontal section through test specimen.

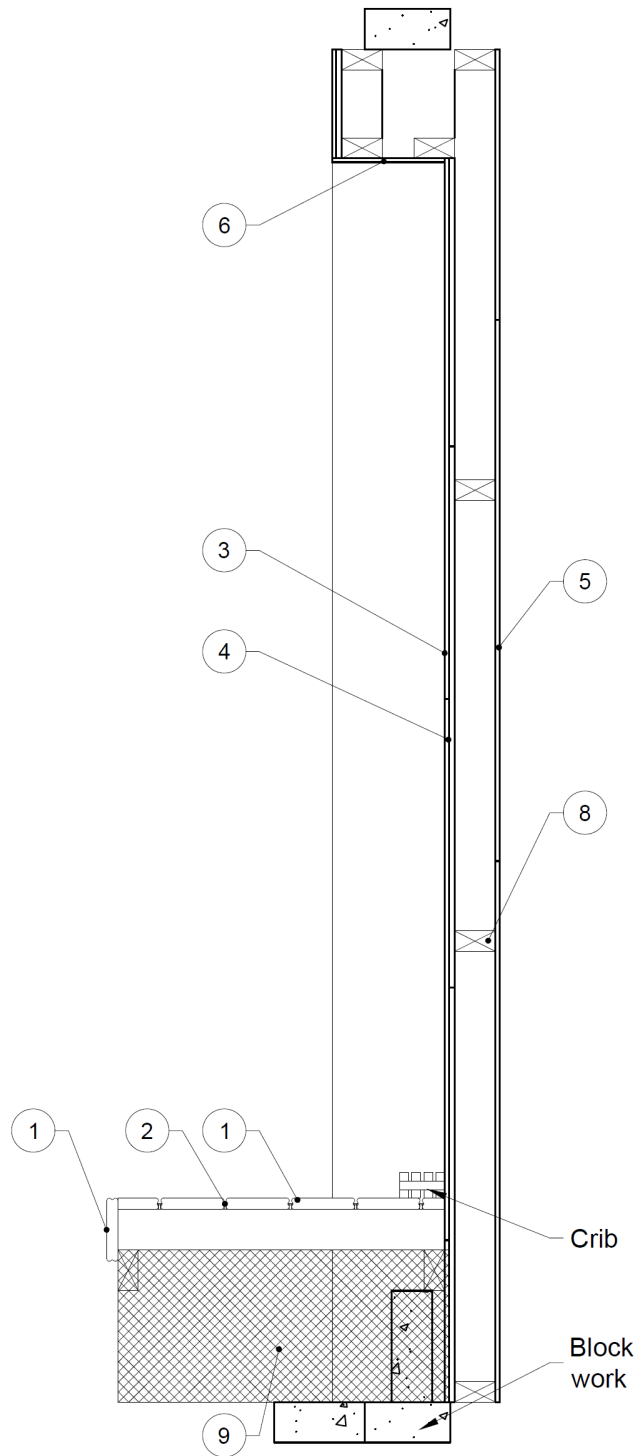
Figure A1.3: Vertical cross section through test specimen.

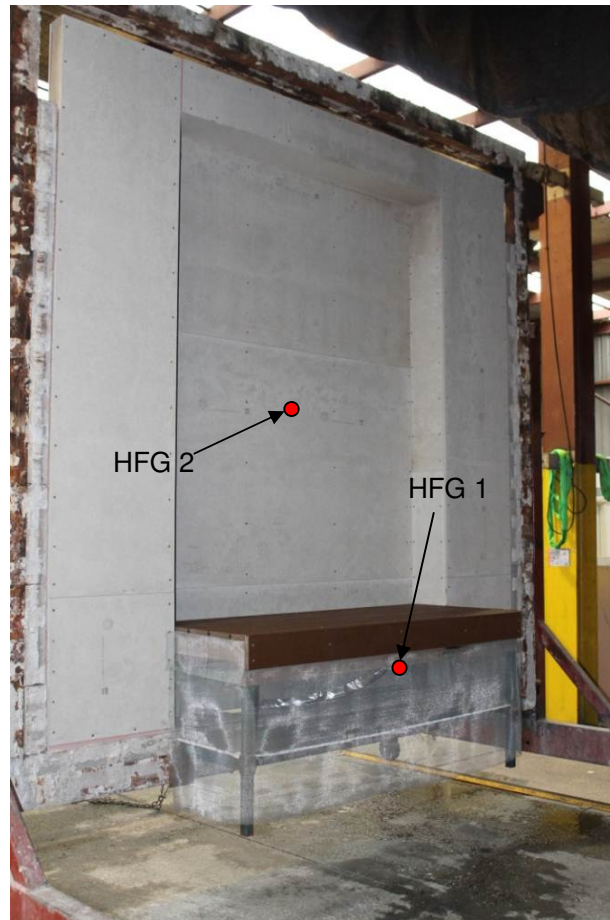
Figure A3.1: Heat Flux Gauge locations on exposed side
HFG 1 centrally located across the deck, nominal 50mm below the bottom of the deck.
HFG 2 located at the centre of the wall.

The radiation received at the front of the deck system was measured by a heat flux meter for the radiant exposure portion of this test.

A second radiometer was placed in the centre of the wall to provide additional information.

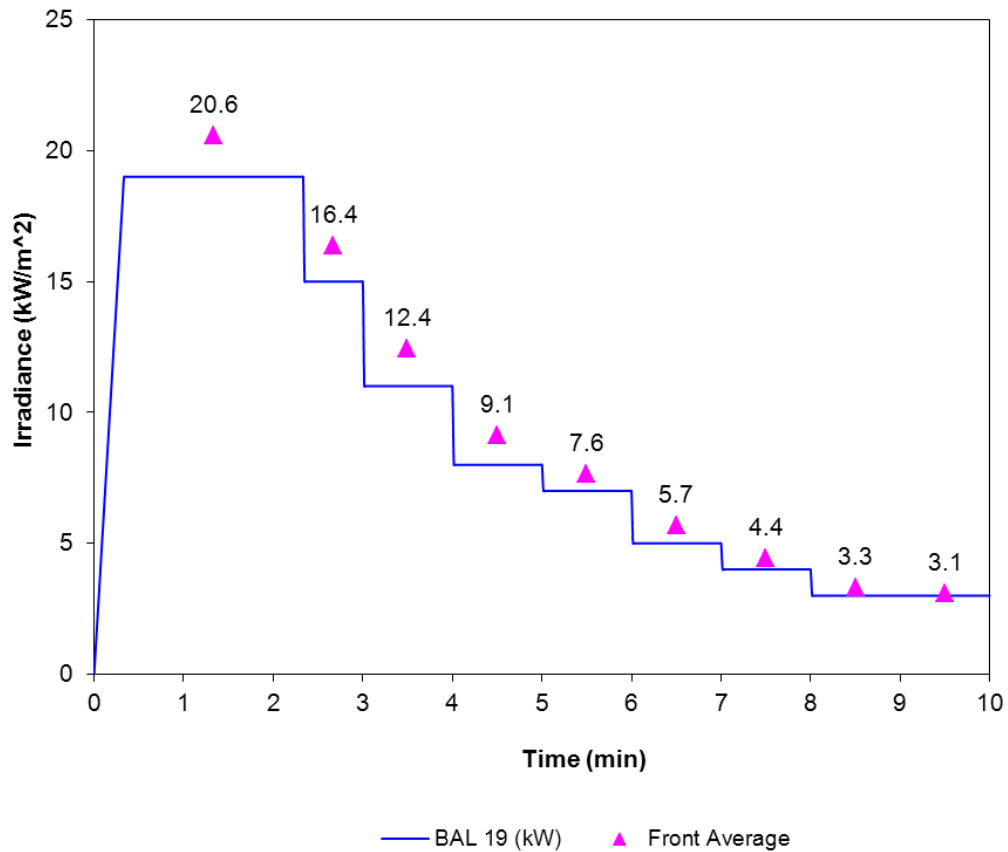
Figure A4.1: Irradiance levels received at the front of the decking system

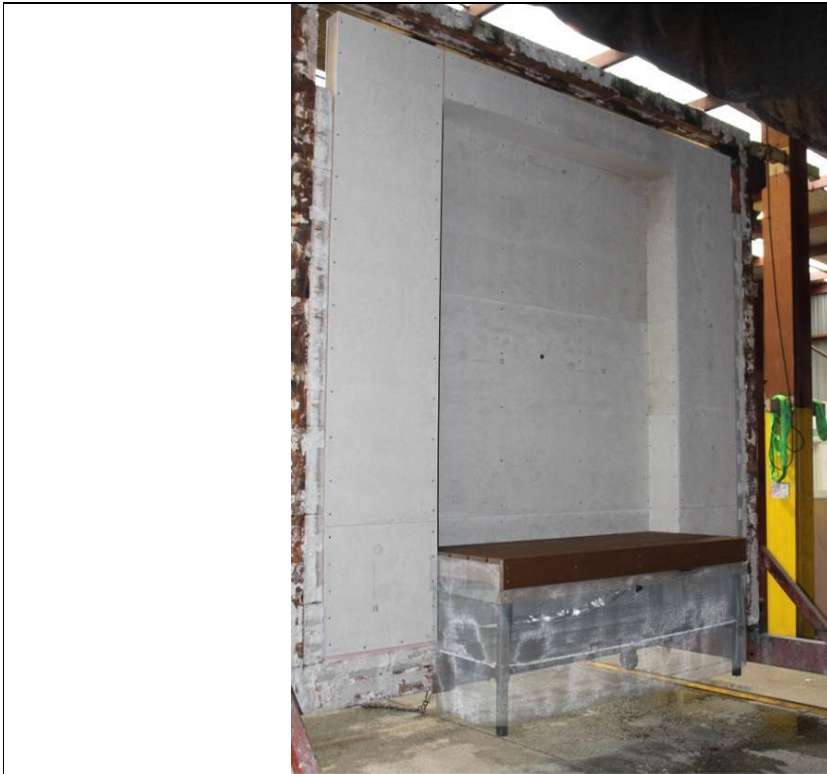
Figure A5.1. Exposed face of specimen before commencement of the test.

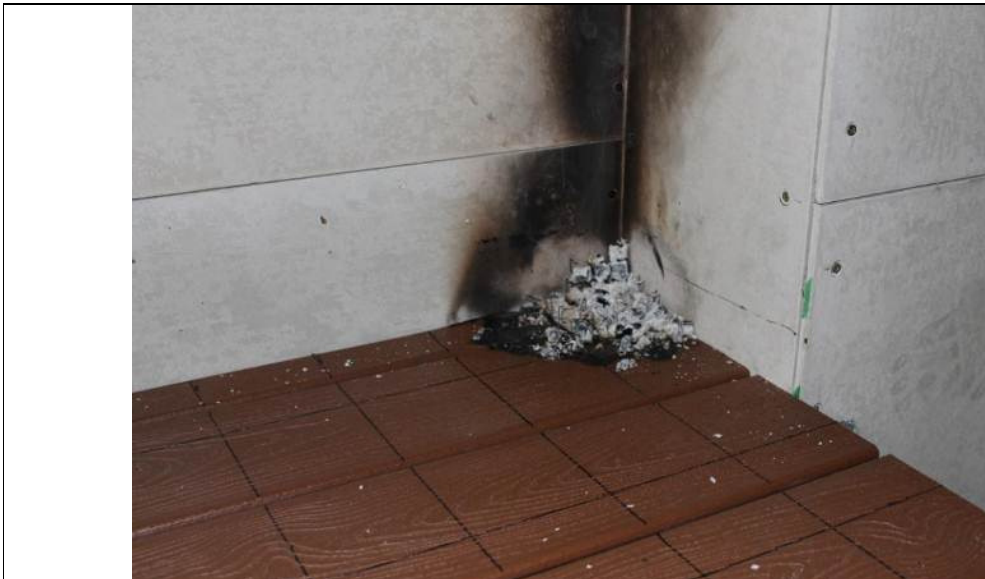
Figure A5.2. Exposed face of specimen at the conclusion of the test.

Time Min Sec		Observation
0	00	The bushfire test was commenced and ambient air temperature was approximately 28°C. The ignited crib have been positioned in its respective location
0	10	Radiation exposure of the specimen had commenced.
0	47	Smoke emission had become evident on the front and leading face of the deck
1	37	It had become evident that the flaming on the crib had spread to the deck.
3	44	It had become evident that flaming on the deck adjacent to the crib had spread 100mm at both direction
10	00	Exposure to the radiant heat source had ceased in accordance with the procedure of AS 530.8.1-2007
22	00	It had become evident that the flaming appeared on the interface between the deck and the wall near the crib
36	00	It had become evident that the flaming on the deck had self-extinguished. It had become evident that glowing appeared on the interface between the deck and the wall near the crib
60	00	The bushfire test was stopped in accordance with the procedures of AS 1530.8.1-2007
